Migration of a Broken Drill Bit After Acetabular Fracture Fixation. A Case Report

Department of Orthopedic Surgery, University Malaya Medical Center, Kuala Lumpur, Malaysia

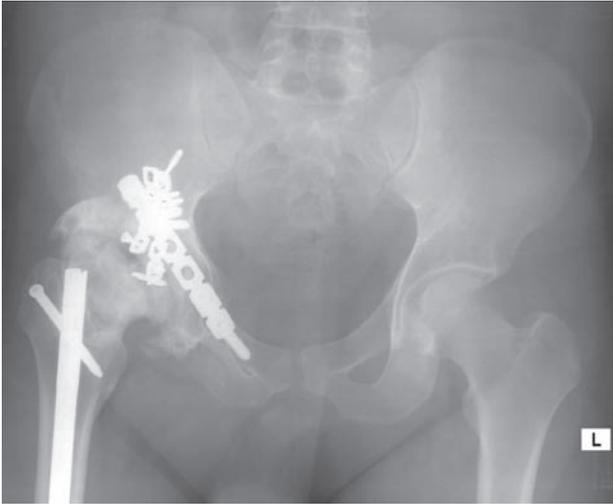
Fig. 1: Plain radiograph shows fixation of right acetabular with multiple plates and screws and a broken drill bit, IM interlocking-nail for shaft femoral fracture and avascular necrosis of right femoral head (May 2009).

He began to complain of right hip pain of increasing intensity 3 months later, and was diagnosed to have osteonecrosis of the right femoral head. Radiographs of the right hip also revealed a broken drill bit near the acetabular plate but within the bone. (Figure 1) Following removal of the interlocking nail and two of the three plates, right total hip replacement was performed soon after the review. (Figure 2) His immediate postoperative recovery was uneventful. However, 6 months following the total hip replacement procedure, he began to complain of right groin pain, especially with movement. Despite physiotherapy and analgesia, his pain persisted and a swelling was developing in the groin region.

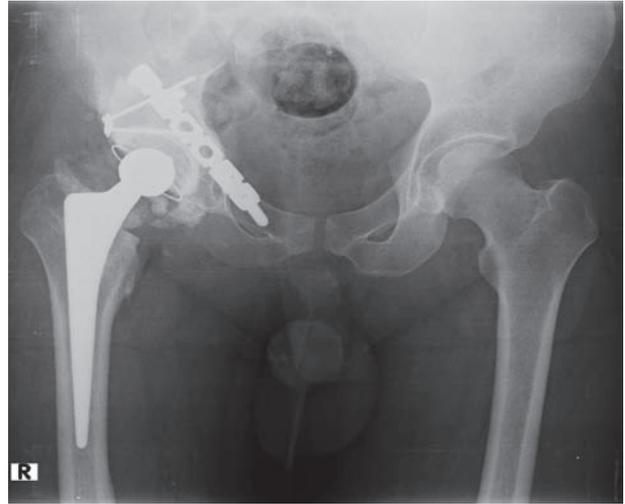
Fig. 2: Plain radiograph after right THR and removal some plates and screw of acetabular fixation (October 2009).

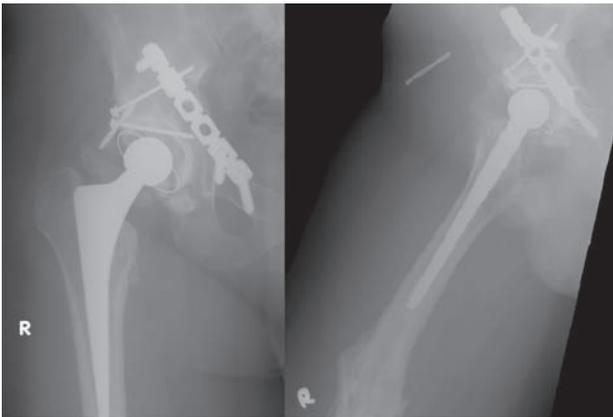
Fig. 3: Plain radiographs show migration of a broken drill bit to the posterolateral aspect of the right hip (September 2010).

On physical examination, the right groin appeared swollen with a sharp tip palpable over the swelling. It was extremely tender to touch. Lateral plain radiograph showed migration of the broken drill bit to the subcutaneous tissue anterior to the right hip joint. (Figure 3)

We suspected that this migrated broken drill bit was causing the groin pain and decided to surgically remove the hardware immediately. In the present case, a broken drill bit migrated to the subcutaneous tissue anterior to the acetabulum and could have caused injury to the adjacent femoral nerve or blood vessels. We informed the patient about potential complications if the hardware was not removed and also risks during the surgery to remove it.

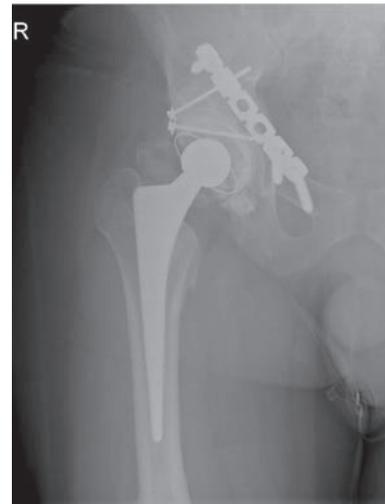
Fig. 4: Plain radiographs after removal of a broken drill bit.

We removed the hardware quite easily under local anaesthetic because it was quite superficial. Postoperative recovery was uneventful, and the pain and swelling then resolved completely.
