## Black Metal Knee in 25 Years Old Total Knee Arthroplasty

<sup>1</sup>Mawardi M; <sup>2</sup>Azhar A; <sup>2</sup>Fauzey K; <sup>2</sup>Aizat AS; <sup>2</sup>Hafizuddin AS

<sup>1</sup>Orthopaedic Department, Hospital Sultanah Bahiyah, Alor Setar Kedah

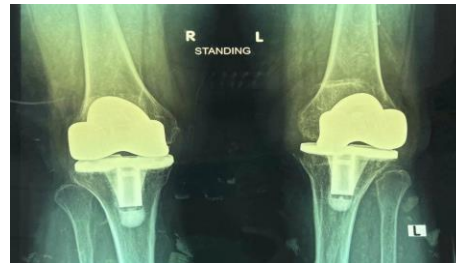
FIGURE 1: Pre-operative x-ray

A 75-year-old women presented with chronic left knee pain and instability, which gradually worsened over the past two years. Notably, she had a history of TKA performed 25 years ago at another center. Despite the absence of recent trauma or constitutional symptoms, her symptoms were concerning, especially considering her history of TKA. Upon examination, the patient demonstrated varus laxity in the affected knee along with limited range of motion. Septic parameters were within normal range. Preoperative X-rays (picture 1) revealed significant pathology, including reduced joint space, femoral component subluxation over the tibia component, subsidence of tibia tray into the proximal tibia. Given the findings, revision total knee arthroplasty was deemed necessary. During the surgery using the Attune Revision Knee Systems and sleeve, intraoperative findings included the presence of blackish synovium (picture 2) covering the knee. No evidence of infection was found. There were fractures in the posterior part of the polyethylene and erosion of the posterior part of the tibia tray. Significant bone defects were observed in both the tibia and femur, classified as AORI type 3 after removing the initial implant. Post-operation, the patient's recovery appears to have been satisfactory. She no longer requires a walking frame and can ambulate without crutches. The Knee Society Score of 92 suggests good functional outcomes and satisfaction with the surgery.

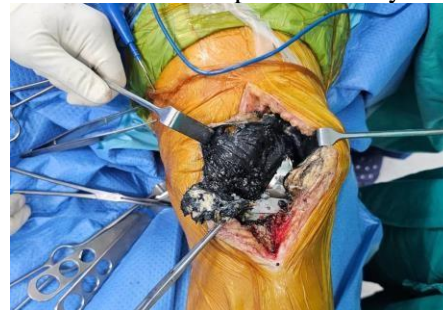
Figure 2: Intraoperative finding show blackish synovium

The most typical locations for metallosis descriptions are high-wear joints like the hips and knees. The most common cause of metallic debris in Total knee arthroplasty is polyethylene liner deterioration or failure. Other factors leading to the aforementioned include soft tissue imbalance, trauma, and prosthetic loosening. In our instance, significant metal-on-metal articulation was caused by attrition on the tibial insert. Patients with metallosis are treated with revision surgery and synovectomy. Any surgical procedure should only begin after an infection has been ruled out.

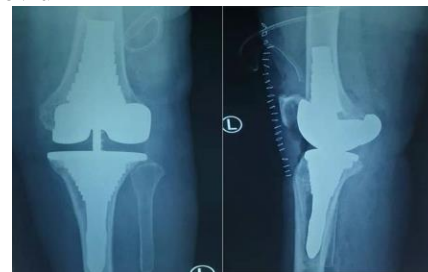
Figure 3: Post-operative x-ray
