Not A Fairy Tale Solution: Complication of Femoral Neck System In A Comminuted Neck Of Femur Fracture

¹Department of Orthopaedic, HUSM, Kelantan, Malaysia

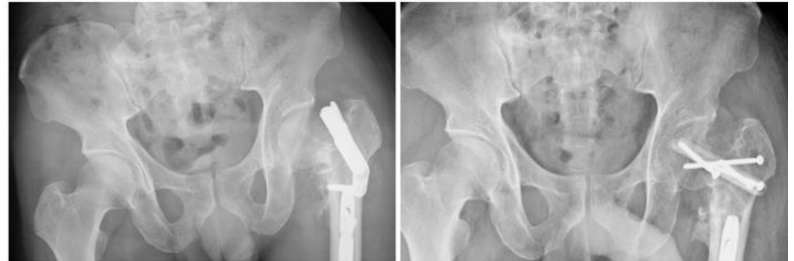
Figure 2: Pelvic X-Ray: C- 3 Months Post Operation D- Post Fibular Strut Graft

During the patients follow up at three months, we noticed that the implant had already failed as the blade has been cut out on top of evidence of avascular necrosis of the hip.

Non-union, avascular necrosis of the NOF and implant failure are the complication that has all been seen with this case that leads to patient morbidity. There are little to no evidence to suggest that FNS is a superior implant when it comes to treatment of comminuted NOF fracture.

To address the complication a fibular strut graft over the neck of femur to promote bone healing and to arrest the progression of avascular necrosis of the NOF was done.

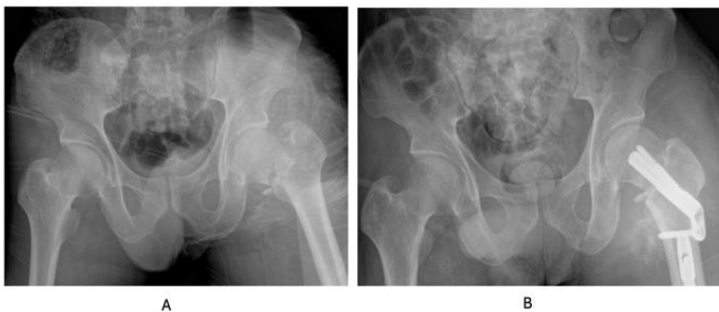
Figure 1: Pelvic X-Ray , A- Trauma X-ray B- X-ray post fixation

MR X is a 43 years old gentleman and sustained a segmental femur fracture after being involved in an MVA. The choice of implant chosen after taking into consideration of fracture pattern were retrograde femoral nail and FNS for the NOF fracture and were fixed sequentially. Intraoperatively the fracture assessment by the surgeon noted to be comminuted with minimal medial buttress and had difficulty attaining reduction and open reduction of the fracture were done resulting in a shortened NOF
