A Rare Presentation Of Isolated Traumatic Osteochondral Fracture Of Medial Facet Of Patella

Loh KW, Daud H, Abdul Rahman I, Nasirudin N

Department of Orthopaedic Surgery, Miri Hospital, Jalan Cahaya, Miri, Sarawak, 98000, Malaysia.

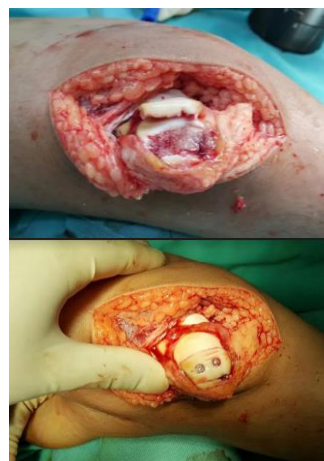
Figure 1: Intraoperative photograph showing fracture morphology and completed osteosynthesis

The surgery was performed five days after hospital admission. Intraoperative findings revealed a 4x3cm osteochondral fragment with intact medial patellofemoral ligament and medial retinaculum. The surgical technique used consisted of open reduction and osteosynthesis with two 2.7-mm cortical metal screws in the osteochondral fragment of the patella. Patient recovered well with complete range of motion and able to ambulate independently
