An Unusual Case of Prosthetic Joint Infection Due To *Elizabethkingia anophelis* ¹Simmadorai KB; ²Ganthel K; ³Ho J; ⁴Singh S

Joint Replacement Unit, Hospital Kuala Lumpur 50586 Kuala Lumpur, Malaysia

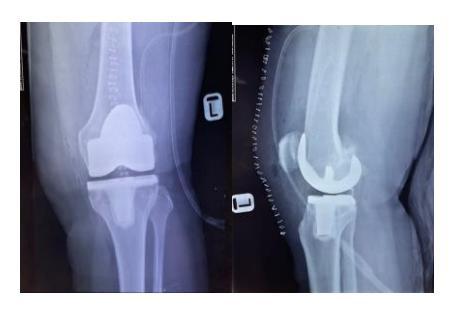
Figure 1: Immediate post operative Radiograph

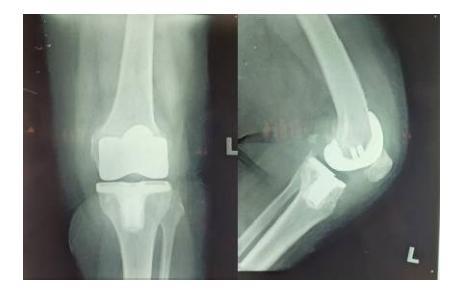
Figure 2: Post-operative 8 months Radiaograph showed area luceny at femoral component

A fifty-year-old female, admitted to the orthopaedic ward of Kuala Lumpur Hospital for a persistent pain and swelling of left knee. Medical history included a left total knee replacement done 8 months ago with known allergy to nickel. Examination revealed that there is area of lucency at the femoral component of her left knee prosthesis. Laboratory data included а Erythrocyte sedimentation rate (ESR) level of 77, and a Creactive protein level of 23.8. Knee joint aspiration was performed and a 15cc of strawcoloured synovial fluid was aspirated. Gram stain of the the synovial fluid smears showed Gram-positive bacilli, hence prosthesis was removed and replaced by a spacer. Intra synovial fluid were sent to operatively laboratory and tested for aerobic and anaerobic organisms. As the patient was apyretic, blood cultures were not performed. Intravenous Cefazolin was started until the microbiological results were available. The cultures grew Elizabethkingia anopheles. The presence of this bacterium in the peri-operative samples led us to consider this bacterium as the origin of the total knee prosthesis infection and its loosening. Patient was referred to Infectious Disease team and Intravenous Vancomycin was commenced
