Retrograde Cement Extrusion Into Femoral Nutrient Vessels Following Uncomplicated Total Hip Arthroplasty: A Case Report

Lim CH, Jacob VA, Premchandran N

Department of Orthopedic, Hospital Tengku Ampuan Afzan, 25100, Pahang, Malaysia.

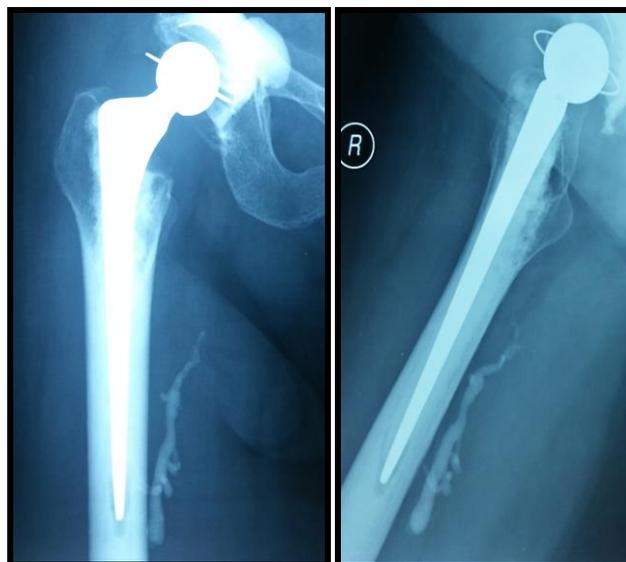
The post-operative radiograph demonstrated a linear radio-opacity communicating with the posterior aspect of the femoral shaft which continues proximally and medially for approximately 10cm. Its uniformity in shape and position corresponds to the vascular supply of proximal femur. In Farouk et al cadaveric study [1] nutrient vessel arises in 166 ± 10 mm from the greater trochanter and is a branch of the second perforating artery from the deep femoral artery. Knight et al [2] infer that retrograde cement extrusion occurs in female patients with small stature and small endosteal canal. Cement extrusion unlikely will influence the long haul survival of prosthesis as shown in the radiograph that cement is well pressurized to interlock with the endosteal bone.

Cement extrusion into the nutrient foramen is a vital differential in presence of posterior medial cement in the diaphysis of the femur following total hip replacement. This is to differentiate from extra osseous extrusions due to the iatrogenic breach of the femoral cortex suggesting periprosthetic fracture which affects the long term survival of prosthesis.
