Peri-Implant Hoffa Fracture Of The Lateral Femoral Condyle: A Case Report

Ho WS, Chin HK, Muhaimin A, Ng TS

Department of Orthopaedic Surgery, Melaka Hospital, Jalan Haji Mufti Khalil, Melaka, 75400, Malaysia.

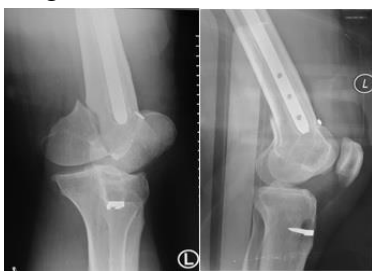
Figure 1: Trauma radiograph showing intact intramedullary nail and Hoffa fracture of the lateral condyle. The previous femoral tunnel created can be seen.

We report a case of a 22 years old gentleman with history of motor vehicle accident 5 years ago, following which left femur intramedullary nail was done. He also sustained left anterior cruciate ligament tear which was reconstructed 2 years later. This gentleman sustained another motor vehicle accident and complained of pain over his left knee. The knee was swollen and tender on examination with intact neurovascular status. Radiographs were taken and shows coronal fracture of the left lateral femoral condyle (Fig. 1).

Hoffa fractures appearing as peri-implant fracture has yet to be reported. In this particular case, the intramedullary nail would have neutralized the force during trauma but act as a stress raiser at the distal end of the nail. This would have lead to the deforming forces being concentrated at the region of distal femur. Furthermore, the previous femoral tunnel created during the ACL reconstruction formed a weak point causing fracture initiation and propagation.
