Revision of Total Ankle Replacement Implant After Aseptic Loosening Secondary to Metal Hypersensitivity

¹Orthopaedics Department, Hospital Queen Elizabeth II, Kota Kinabalu, Sabah, Malaysia

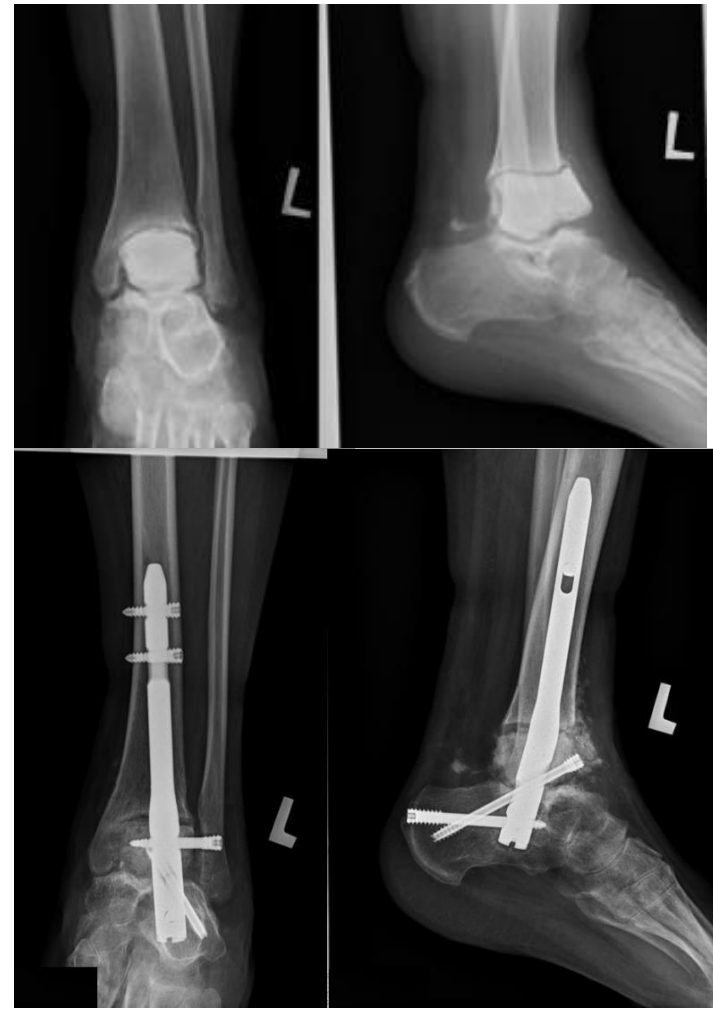
5 months post-TAR, patient presented with a sinus over anterior ankle preceded by swelling. Clinically joint not inflamed, radiographically noted loosening of implant. Inflammatory, infective markers not markedly raised, however noted eosinophil count increased. Initial management with arthrotomy washout, removal of implant and insertion of cement spacer was performed, intraoperatively no signs of infection seen, histopathological examination and cultures not indicative of ongoing infection.

Figure 1: post removal of TAR, bone cement spacer insertion

Initially planned for a revision of left ankle arthroplasty with custom made, 3D-modelled talar implant with hypoallergenic alloy, alas as implant was not available, opted for ankle fusion to regain early mobility.

Ten months post removal, proceeded with left ankle hindfoot fusion with femoral bone allograft and demineralized bone matrix. Implant used was tibiotalar calcaneal arthrodesis system, composed of Ti6Al4V alloy³, patient asymptomatic postoperatively locally and systemically. Post-operatively, patient was able to ambulate with air cast application, and regained full mobility without walking aid at 3 months
