Management Of A Comminuted Talus Fracture With Headless Compression Screws: A Case Report

INTRODUCTION:

REPORT:

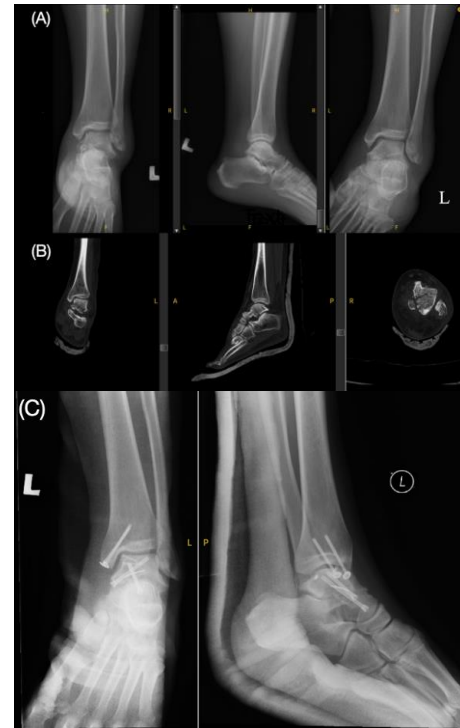
Clinical pictures : (A) X-rays AP/lateral/mortise views – Suspicious fracture line traversing taller neck (B) CT images coronal, sagittal and axial views - confirms presence of comminuted talus fracture. (C) Post fixation

A 36-year-old woman presented after a motor vehicular accident with a suspected talus fracture. CT-scans confirmed a comminuted talus fracture involving the body, neck, tibiotalar, and subtalar joints. The patient underwent surgery with a medial malleolus osteotomy combined with the anterolateral approach for full visualization of the fracture site. Comminuted fragments were meticulously reduced and temporarily fixed with K-wires. Headless compression screws, chosen for stability and a low-profile design, were used to traverse and compress the fragments. Postoperatively, the patient was monitored in the ward for five days, and weight-bearing was strictly prohibited. After transitioning to a removable cast, the patient was discharged uneventfully. Postoperative care focused on protecting the initial fixation during the early healing phase, with gradual transitioning to weight-bearing based on fracture consolidation and inclusion of physical therapy for functional recovery.
