Removal Of Broken Intramedullary Femoral Nail With An Unusual Pattern Of Breakage: A Case Report

Liong MF, Ezrat B Samadi, Felix LYS

Jabatan Ortopedik & Traumatology, Hospital Ampang, Selangor

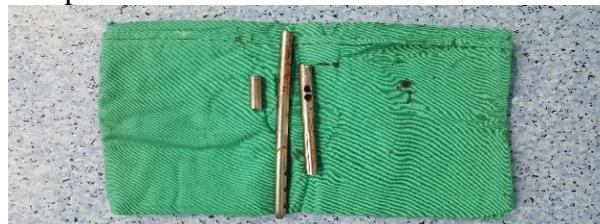
Figure 2: Intramedullary femoral nail broken in 3 parts removed completely.

Patient was positioned on traction table. The proximal nail fragment removed via previous entry point. Another incision made over non-union femur fracture site to reach middle and distal nail fragment which removed via pull out technique using bone rongeur. Intraoperatively, there was no sign of infection and abundant fibrous callus seen over femur non-union site. New intramedullary femoral nail sized 11 x 380 mm inserted after fracture site well

compressed.
